Performance of REBAM® during ball bearing failures

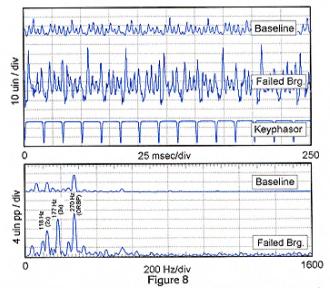
With this in mind, the next step was to use a bearing with extensive spalling and place it under low radial load (300 lbs, 1.33 kN). This was the bearing that was run to failure in the axial load failure test (the data from this failure progression will be discussed in the next issue of Orbit in part II of this article). It contained spalling on the inner raceway and several of the elements. The signal levels were then compared with the baseline levels at the same load. The speed was again 3550 rpm. Figure 8 shows the signal from the Channel 1 REBAM® probe for the baseline and failed bearings. The signal from the Channel 1 probe showed a 130 percent increase in overall signal level, Chan-▶

Baseline and failed bearing data under 300 lbs. (1.33 kN) radial load as seen from Channel 1 REBAM $^{\$}$ Probe.

nel 2 showed a 160 percent increase, Channel 3 showed a remarkable 860 percent increase, and Channel 4 increased by 214 percent. The large increase seen on Channel 3 is due to its small baseline amplitude. This shows one very important point: If a REBAM probe is mounted directly opposite the center of the radial load zone in a bearing under pure radial loading, you may not see a large signal when the bearing is healthy or new, but when the bearing fails, it will likely produce enough deflection in the outer ring to produce a large change in signal amplitude. Much of the change occurred at the outer race element pass frequency, but we also see a large change in the components in the rotor frequency region, particularly the 2X and 3X components.
